# The Old BARN POST

*A publication of Friends of Ohio Barns • October, 2018 • Vol. XVII, Issue 3*

# Timber Frame Shelter Protects Ancient Native American Heritage Site

# Get your Mind *IN* the Gutter!

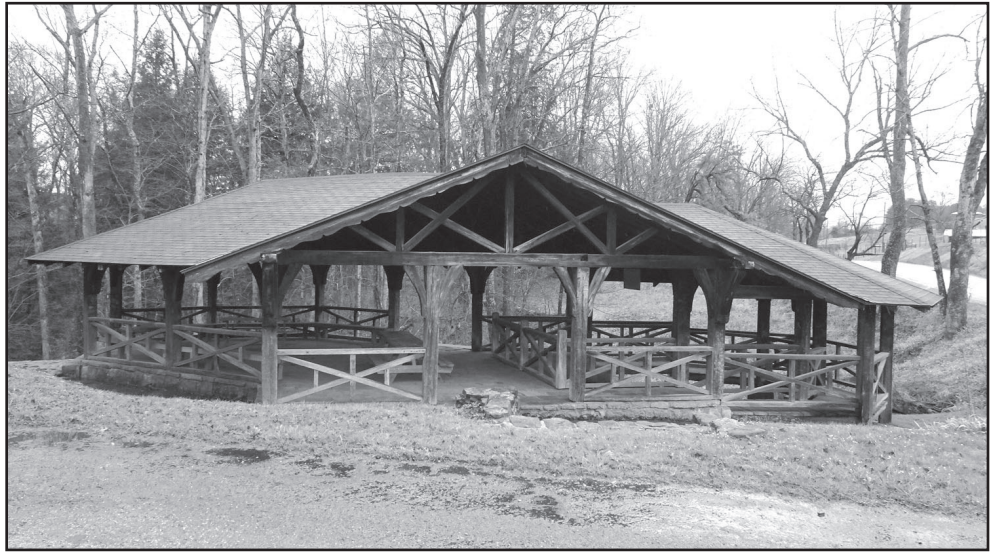
**Timber frame shelter house at Leo Petroglyph. The right side covers the Native American heritage etchings in the sandstone outcrop. The left side is a picnic shelter.**

The hand-hewn timber frame shelter house protects the etchings from rainfall and any other onslaught of the elements. A walkway around the outcrop allows visitors to look over the pegged railing for close views of the figures. Under the same roof the shelter was extended to allow for picnic tables and built-in benches. The picnic area was laid out with a flagstone floor and the roof rafters converge at a point creating a half hexagon, vaulted space on that end of the shelter.

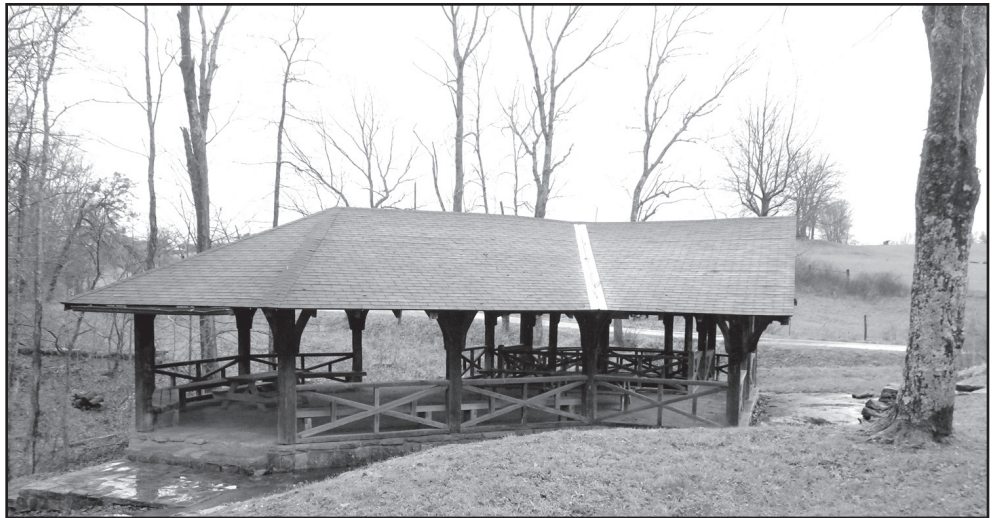
**Above: Side view of shelter with half a hexagon covering the picnic area to the left.**

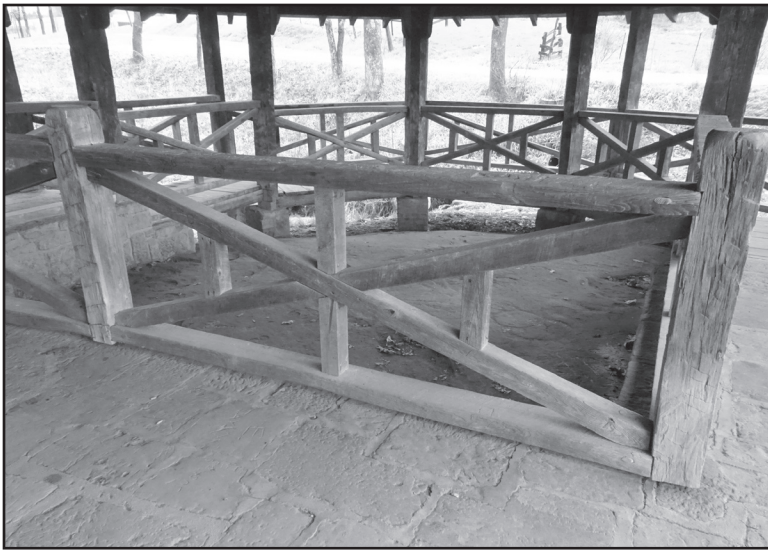
Wooden pegged railing and walkway surrounding the petroglyph.

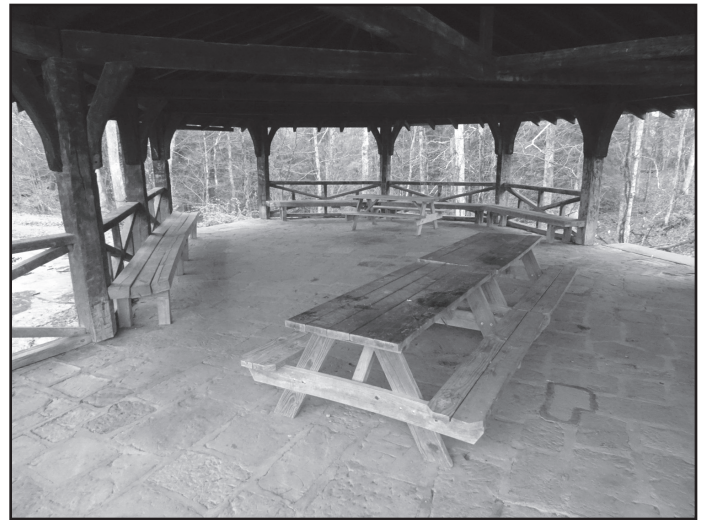
Large picnic pavilion area with flagstone floor and hewn pegged railings and braces supporting the roof system.

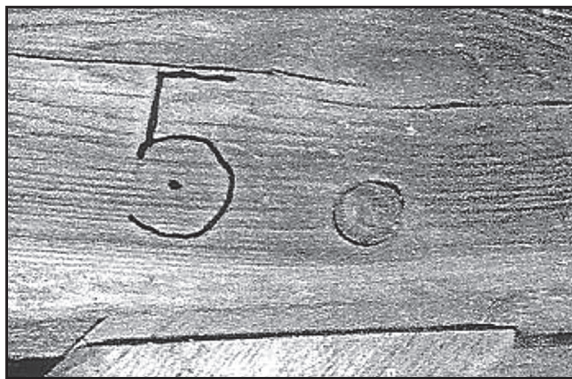
Above: Arabic marriage marks made with auger bit and finished with a chisel

But Sam Hipsher shows us a new twist on marriage marks. In his old 18th century barn the bents were marked with Arabic numerals. The builder used an auger to make a light circular mark then added straight marks with a chisel to form the various Arabic numerals. In the accompanying photo and illustration notice how the auger bit was tilted to leave an open side on the circular base of the "5" with straight lines being added to complete the number. (The photo has been enhanced). Visualize the other Arabic numerals, with all the round portions of the numbers being made with an auger bit.

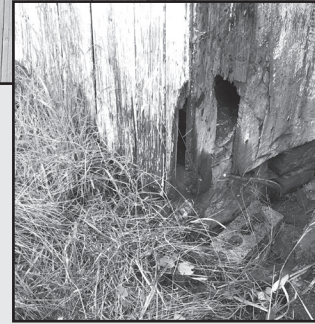
**A rotten sill is the result of disconnected gutter.**

The story plays out from here as so many others have and will. Water had run out of the gutter and down the barn, saturating the wood and penetrating the foundation. Rot, decay, and living organisms consumed the wood fibers, while the water washed out the bed mortar between the stones, destabilizing the foundation one frost at a time. Now you're probably wondering what the point of this little story is: at \$7.00 a linear foot for seamless 6" gutter (labor & materials), it is way too cheap to not maintain your gutters!! Pay attention to how your gutters and downspouts work, call a gutter company if they're not right, otherwise you'll have to call someone like me for major repairs that could've been easily avoided.
