# Introduction to Federal Tax Credits for Rehabilitating Historic Buildings

## Barns

National Park Service  
U.S. Department of the Interior  
Technical Preservation Services

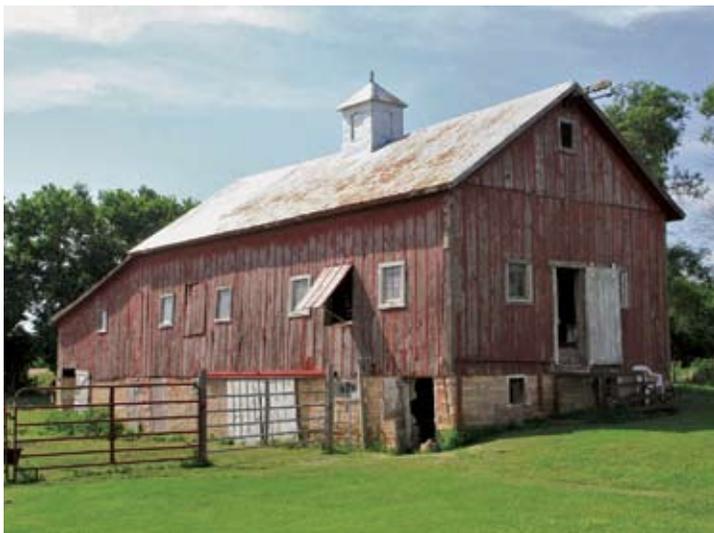
A common building type, bank barn construction allows ground entry from two levels. *Photo: Brenda Spencer, Kansas Historical Society.*

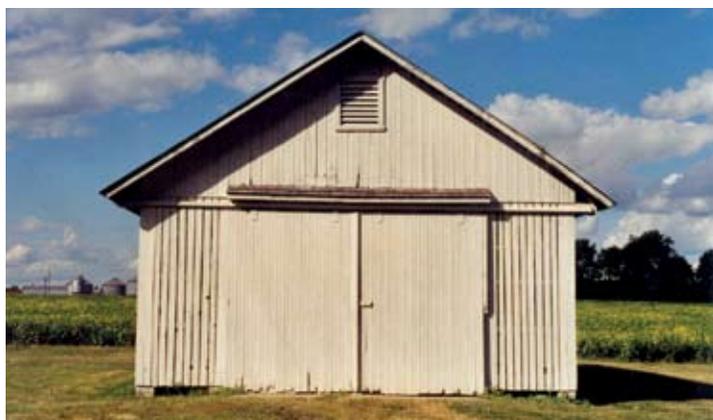
The sliding door is an important feature of this simple farm building.  
Photo: Thomas Vitanza, NPS.

Historic doors are another prominent feature and should be preserved or replaced to match when needed. If you need to enlarge a door opening to accommodate modern machinery, avoid using modern roll up or garage style doors as replacements. Use a design and material that is compatible with the historic appearance of the building. If you no longer need a historic door opening, simply fix the doors closed rather than remove them.

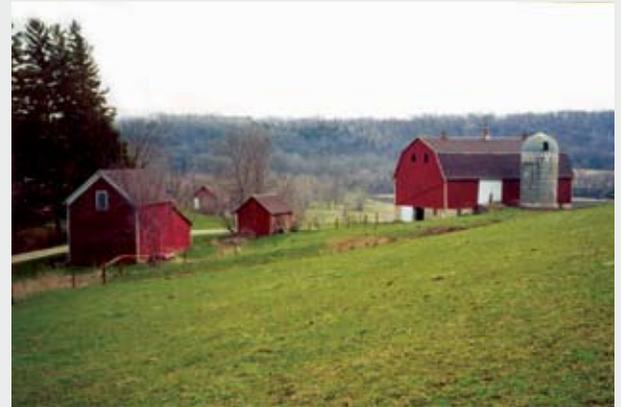
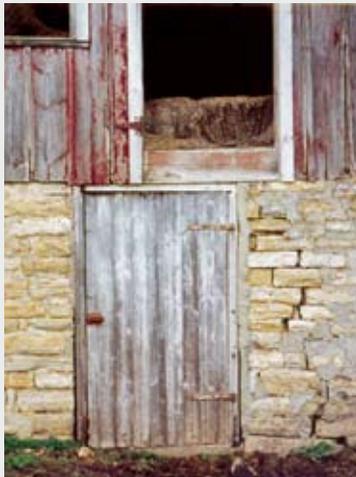
This sample application was developed for the barn on the right pictured above. The image below, left, shows a deteriorated section of the limestone foundation.

Describe existing feature and its condition: The roof has two layers of asphalt shingles over deteriorated wood shingles. There are several portions which are damaged and need replacement.		
Photo no. <u>1-7, 12</u> Drawing no _____		
Number 3	Architectural feature <u>Limestone foundation</u> Approximate Date of feature <u>1909</u>	Describe work and impact on existing feature: The foundation will be repointed where damaged. Mortar will match the existing in color and composition. The joint profile will match the existing as well. Where the limestone is damaged, matching pieces will be used to replace deteriorated sections. New stone will match the existing in color and shape. All work will be done in accordance with NPS Preservation Brief 2.
Describe existing feature and its condition: The limestone foundation is in relatively good condition. Several places have deteriorated mortar joints and damaged stone. There is a large crack at the SE corner.

Foundation repairs are a typical work item in barn rehabilitation. For example, a wood sill may have rotted in sections or termites may have caused damage. In cases where the foundation is not readily visible, either traditional or modern repair techniques can be used. For exposed foundations such as a masonry wall, repairs should be made in a manner that does not alter the historic appearance. Where masonry repointing or repair is needed, appropriate mortar should be used and joints tooled to match adjacent historic masonry.

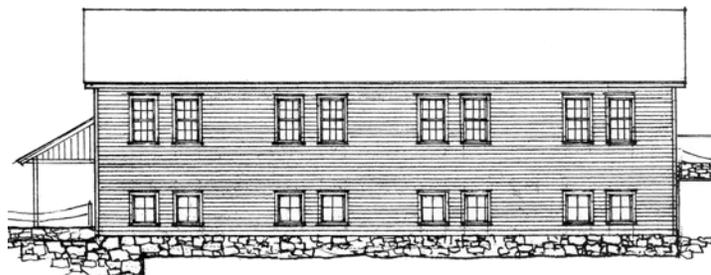
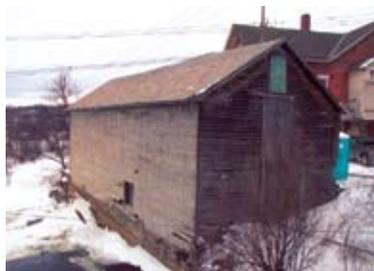
**Inappropriate treatment:** The addition of a large number of regularly spaced windows (shown above) to this primarily blank barn facade (left) does not meet the Secretary of the Interior's Standards for Rehabilitation.

Except for dairy and horse barns, most barns have very few windows. Existing windows should be repaired if possible and replaced with matching ones where needed; avoid enlarging them or otherwise altering their size or appearance. If you must add windows, include only the minimum number required, and ensure that the style, number, and location of new windows are in keeping with the historic character of the barn.

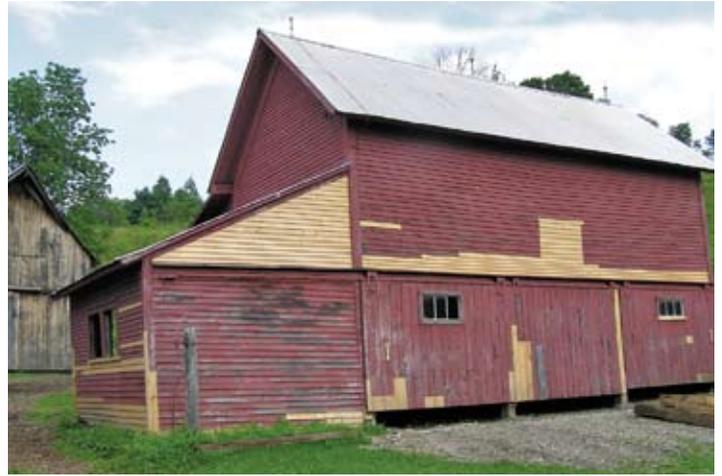
The siding on this barn was repaired with matching siding, a treatment that meets the Secretary of the Interior's Standards for Rehabilitation. *Photo: Vermont Division for Historic Preservation.*

While masonry construction is common in some regions, most historic barns were clad in either horizontal or vertical wooden boards. If portions of the wood siding are beyond repair, or missing altogether, they should be replaced in kind with boards that match the historic size and detailing. Vinyl or metal siding is not an appropriate replacement for wood siding on historic barns.
